BELZONA® SAVES LARGE SPLIT CASE PUMP

Coal Mine
British Columbia

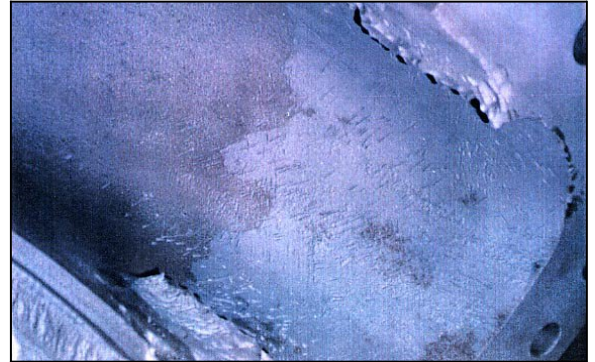
The splitter of this cast iron Worthington split case sludge pump had broken away. The mine engineers had originally discarded the "Belzona fix" and insisted that a new cast section be made and welded into place. This was duly done at great expense. The new splitter was "fared in" with Belzona® 1311 and the pump internals coated. After operating for only a few weeks the pump started producing a rattling sound and on further inspection it was found that the new splitter had come adrift and the only thing keeping it in place was the Belzona® product used to "fare it in". Because there was no replacement, it was decided to go ahead with the Belzona® repair originally suggested but turned down.

1. Photograph shows cast splitter missing. Note the evidence of the specialized welding.
2. Fabrication of new splitter in progress.
3. Fabrication of new splitter completed with the mesh area filled with Belzona® 1311 Ceramic R Metal.
4. Pump internals completely protected with 2 coats of Belzona® 1321 Ceramic S Metal.

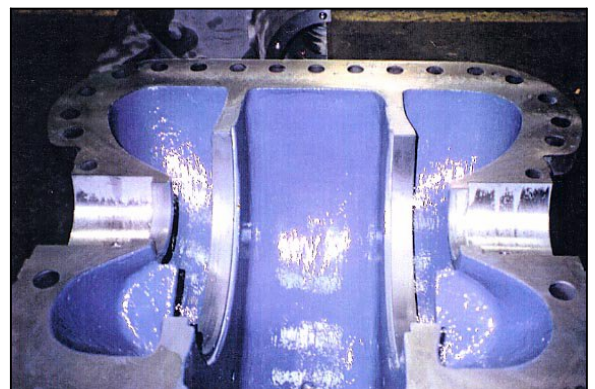
After the 2nd repair using the Belzona solution the pump was returned to service and operated for 2 years at which stage it was removed to replace bearings and packings. An inspection revealed that the fabricated splitter was still in first rate condition and that coating applied to the pump to protect it from sliding abrasion was still in perfect condition. After the overall the pump was returned to service.
