## **BELZONA® 2000 SERIES PRODUCTS SEAL LEAKING VALVE FLANGE**

Power Supply Company

September 1992

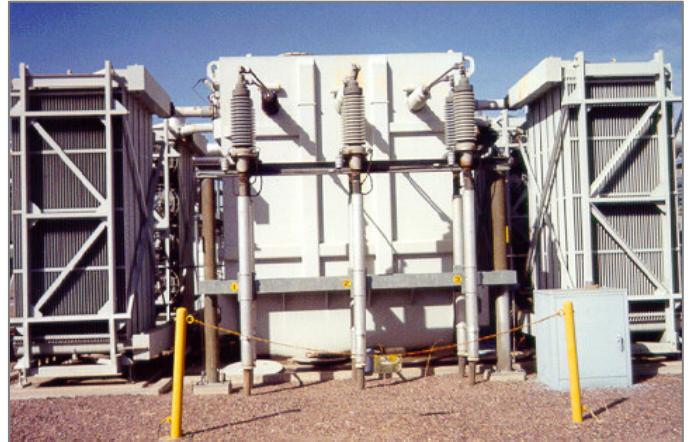
The gasket seal had failed and needed replacement. This would have required draining the tank so that the valve could be removed.

1. View of transformer
2. Application in progress
3. Completed application
