## **BELZONA® REBUILDS DAMAGED DRYER CAN JOURNAL IN 5 HOURS**

Pulp & Paper Facility  
Port Alberni, BC.

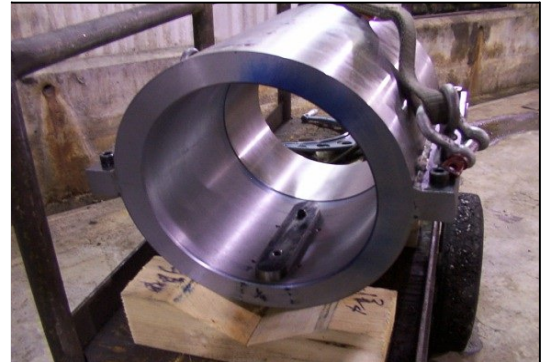
1. View of the complete mold with keyway positioned.
2. Grinding the journal in preparation for the rebuild.
3. Mold in place and the Belzona® 1391 injected from the bottom through injection ports drilled into the mold (See excess material on top of mold).
4. Completed application with reassembly in progress. The light grey surface beyond the inspection light is the newly rebuilt surface.
