## REBUILDING AND SEALING VERTICAL EXPANSION JOINT

HOSPITAL  
Vancouver, British Columbia, Canada

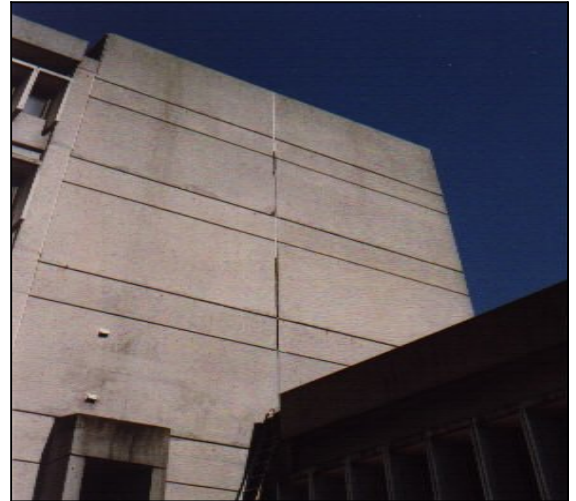
1. General view of 140ft vertical expansion joint
2. Spalled edges repaired with Belzona®. 4111. Application in progress. With special surface conditioning primer applied (purple) and application of 1<sup>st</sup> coat of Belzona® 3111 Flexible Membrane in progress
3. Completed application (*Inset picture taken January 2004*)
