BC KHIA #062

## BELZONA® SEALS LEAKING HOSPITAL CONCRETE ENTRANCE CANOPY

HOSPITAL  
North Vancouver, British Columbia, Canada

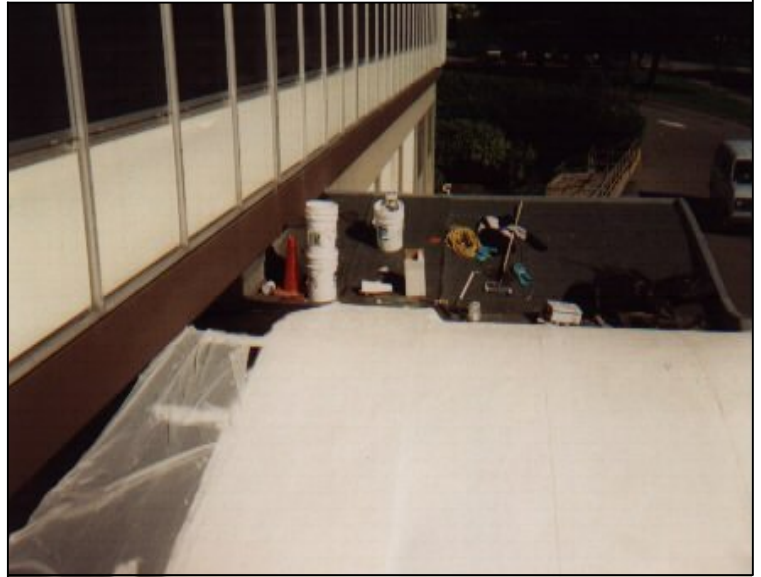
1. General view of roof with application in progress.
2. Completed application

Using Belzona® eliminated the need for repetitive sealing work with no additional maintenance work over the past 8 years. Another advantage was that the previous roofing material could be left in place and the Belzona product applied over the top of it without detriment.
