## BELZONA® RESURFACES ENTRANCE TO PARKING GARAGE

PROPERTY MANAGEMENT COMPANY  
Parking Garage  
Prince George, BC

August 1997

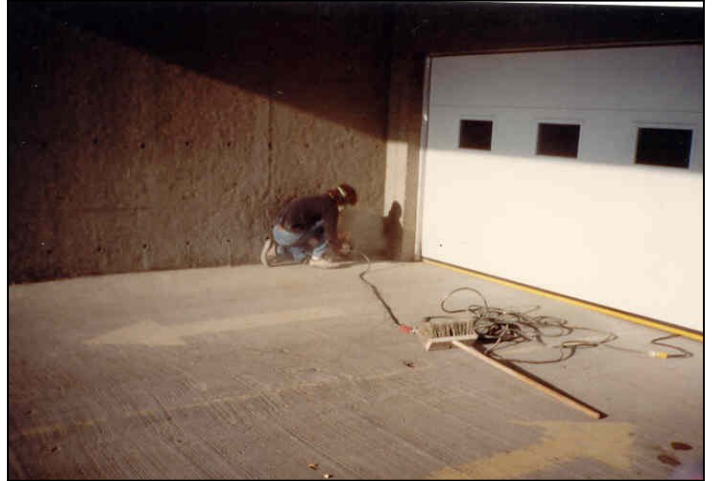
1. View of surface preparation in progress
2. Application of Belzona® 4131 in progress
3. Completed application (Taken after 4 years in service)

Application carried out in accordance with Belzona® Know-How Leaflet RPA-1

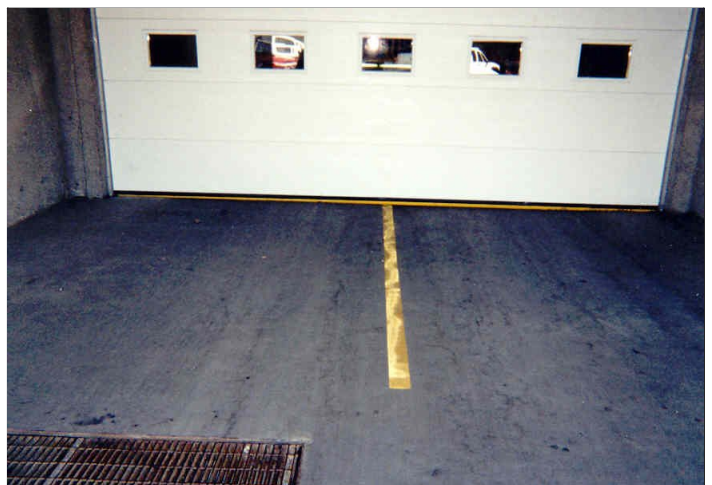
Using Belzona® allowed the area to be resurfaced without having to jack hammer the concrete out to provide space for a standard concrete pour of a few inches. This repair is in a cold climate and is subjected to freeze thaw cycles as well as deicing chemicals. The product stands up to both extremely well and has required no further attention to date.
