BELZONA® REBUILDS KITCHEN EXPANSION JOINTS

HOTEL
Vancouver, BC

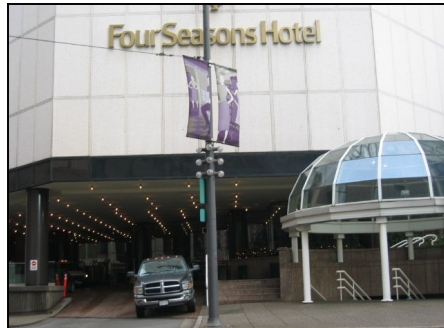
Customer was in the process of refurbishing their banquet kitchen. The original material had sagged causing a tripping hazard. To obviate this the joint was covered over with a stainless steel metal strip which also proved to be unsatisfactory. The refurbishment required that the joint be covered by the new sheet form floor covering. As a result of this the joint needed to be cast level with the existing floor.

1. View of exposed expansion joint with preparation underway.
2. Pouring of joint in progress.
3. Completed application with floor leveled off and new flexible expansion joint cast.

Because of the non-shrink properties of the Belzona material the customer could be assured that the joint could be overlaid without any future sagging concerns. An additional advantage was the quick set up time which allowed the flooring company to cover the joint after 24 hours. Joints similar to this one have been in service in BC for over 13 years without the need for any repair or refurbishment.
