REFURBISHMENT OF PARKING GARAGE ENTRANCE & FLOOR

PROPERTY MANAGEMENT COMPANY
Prince George, BC

August 1998

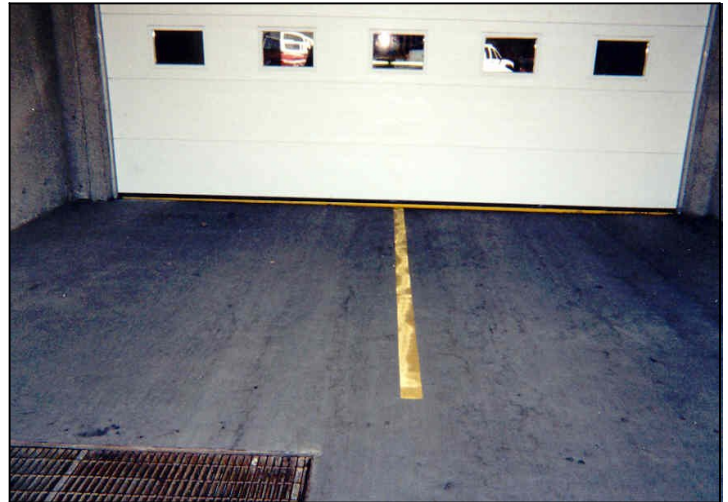
1. Entrance to parking garage resurfaced with Belzona® 4131.
2. All floor cracks were repaired with Belzona® 4111. Areas that needed resurfacing were rebuilt with Belzona® 4131. Expansion joints were filled with Belzona® 3121. Sealing of walls to floor with Belzona 3111. Additionally some exposed exterior concrete work was protected with Belzona 5122 to prevent water penetration.
3. Once these repairs were completed the entire floor area was protected with Belzona 5811 which incorporated a non-slip aggregate.
