BELZONA® REPLACES WORN OUT EXPANSION JOINTS

PROPERTY MANAGEMENT COMPANY
Burnaby, BC

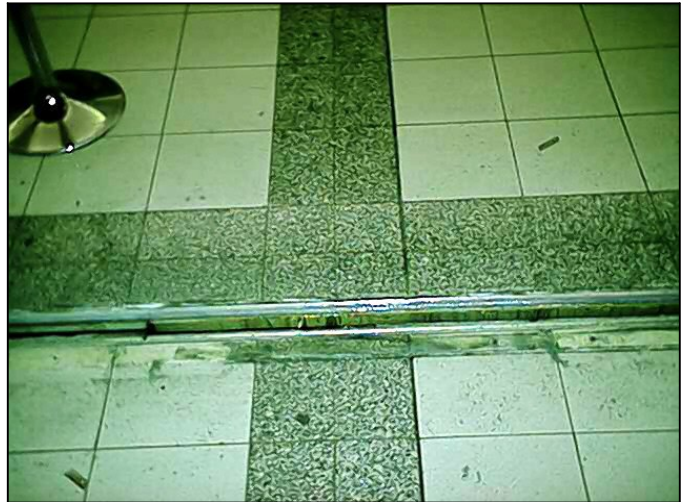
1. View of preparation in progress and old rubber insert removed
2. Application in progress.
3. Completed application

Original patented extruded expansion joint rubber insert had developed cracks and tears compromising safety. These inserts are not readily available. This necessitates the removal and replacement of the entire aluminum extrusion, a long and lengthy procedure.
