BELZONA® REPAIRS DAMAGED STEPS

Community Center
Burnaby, BC

June 2005

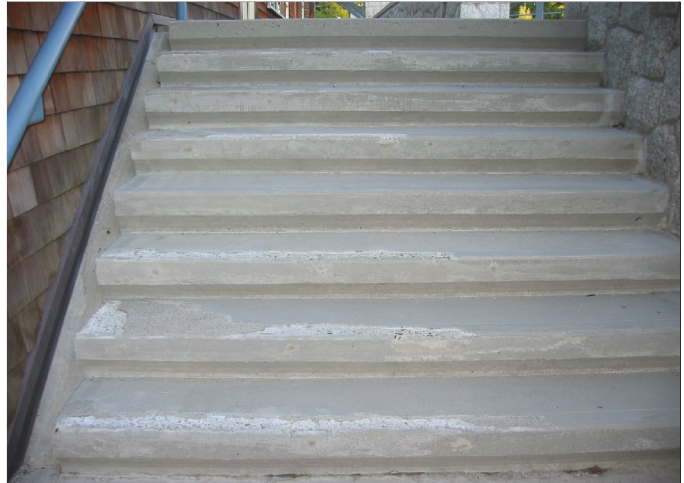
The customer was looking to repair selected spalled areas on steps without having to resurface them entirely.

1. View of spalling stair treads.
2. Close up of repair.
3. View of repaired stairway

Belzona® 4131 Magma Screed.

Application carried out in accordance with Belzona® Know-How Leaflet FPA-1
