BELZONA® REBUILDS AND SEALS PARKING DECK EXPANSION JOINT

Hospital
Miami, Fl

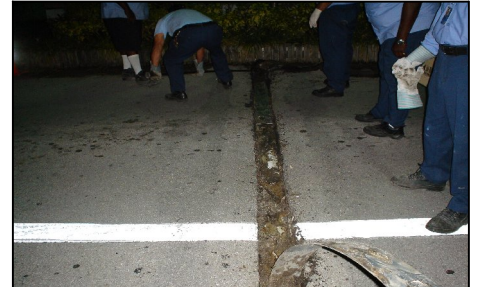
1. View of original expansion joint material in the process of been removed.
2. The exposed area is ground to provide a clean porous and rough surface.
3. The Styrofoam form is in place and a section of the joint is being rebuilt.
4. The joint surrounds have been completely rebuilt and the gap is being prepared for the final stage of the application.
5. Completed application with the narrower expansion recast in place for a perfect seal.
