BELZONA® PROTECTS END COVERS

PULP MILL
Kamloops, BC.

August 1998

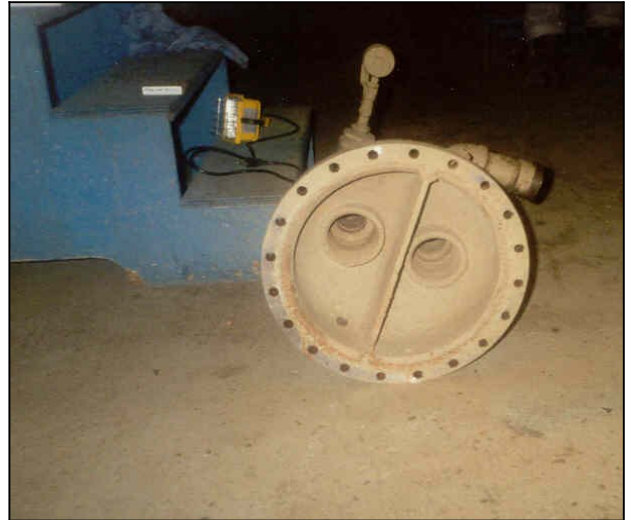
End covers were suffering from bi-metallic corrosion and severe pitting.

1. View of end covers after blasting
2. Repairs to flange faces using plexiglas as a former.
3. Completed application with insides protected with Belzona® 1391.

Belzona® 1311 Ceramic R Metal
Belzona® 1391 HT Ceramic

Application carried out in accordance with Belzona® Know-How Leaflets
HEX-2
