BELZONA® REBUILDS CORRODED END COVERS

OIL REFINERY
Vancouver, BC

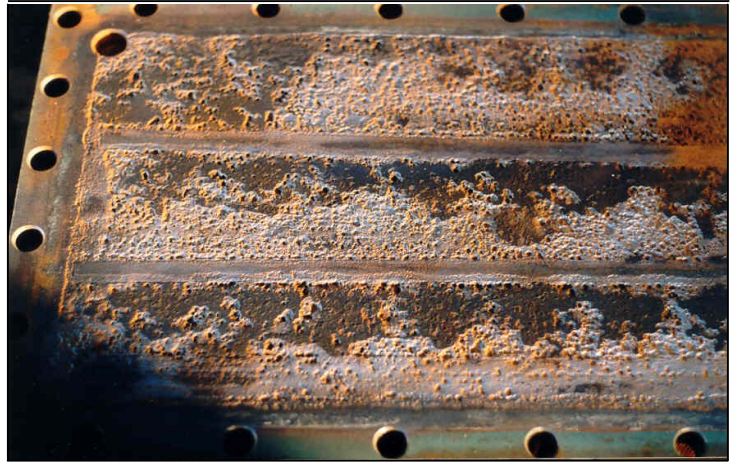
Bi-metallic corrosion had eroded much of the metal making it difficult to effect a good seal along the division bars reducing efficiency.

1. View of corroded end plate
2. Repairs to eroded and damaged areas in progress.
3. Completed application
