BELZONA® PROTECTS AIR HANDLING UNITS FROM CORROSION

Property Management Company
North Vancouver, BC.

May 2005

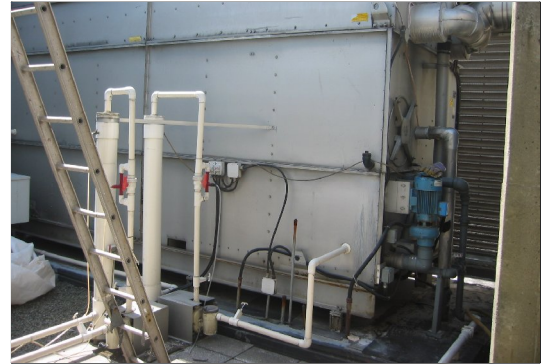
The galvanized coating on the original sheet metal was starting to show signs of corrosion

1. View of the BAC air handling unit.
2. Preparation of the inner metal surfaces in progress.
3. Final preparation of the inner metal surfaces in progress.
4. Application of 2 coats of Belzona® 5811 Immersion Grade in progress.
