BELZONA® 5811 IMMERSION GRADE PROTECTS COOLING TOWER

Property Management
Vancouver, BC

May 2006

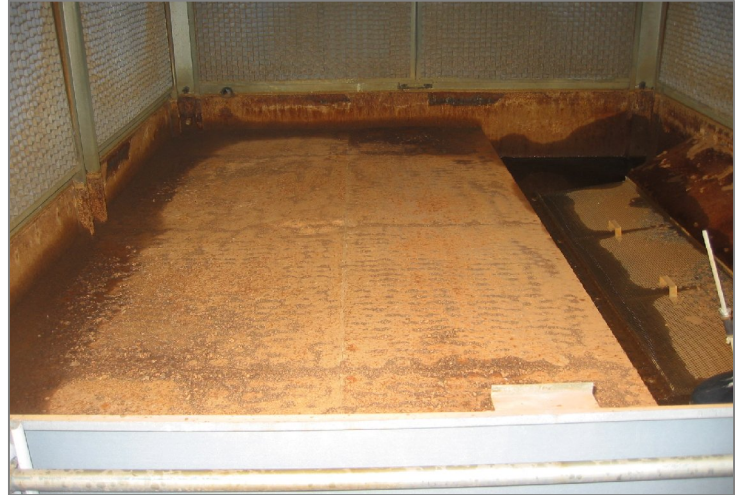
Excessive corrosion was taking hold of the drip tray area of the cooling tower.

1. View of drip tray showing dense corrosion
2. Application of 1st coat of Belzona® 5811 after grit blasting the entire base and sides to a near white metal finish (SSPC SP 10) to remove all traces of corrosion.
3. Application of 2nd and final coat
