BELZONA® PROTECTS CHILLER UNIT FROM BI-METALLIC CORROSION

Property Management
Burnaby, BC

APRIL 2003

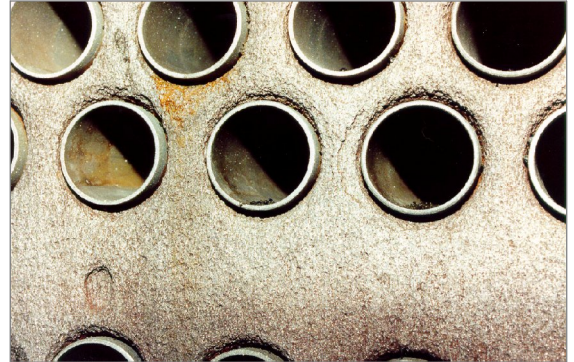
Bi-metallic corrosion was taking its toll between the mild steel tube sheet face and the copper tubing.

1. Photograph shows extent of bi-metallic corrosion between the mild steel tube sheet face and the copper tubing
2. Application in progress with corks in process of being removed from the tubes
3. Application completed and corks removed
4. Close up of final application.

Belzona® 1311 Ceramic R Metal
Belzona® 1341 Supermetalglide

Application carried out in accordance with a modified version of Belzona® Know-How Leaflet HEX 1/3
