## NON MARKING TRANSFER ROLLS IN SAWMILL

SAW MILL  
British Columbia, Canada

October 2001

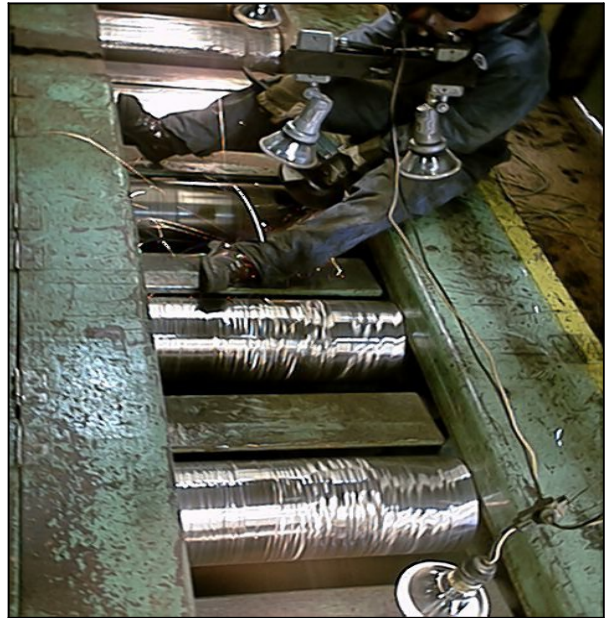
1. View of preparation in progress
2. Close up of application in progress.
3. Completed application

Marked lumber had developed into a major problem at the mill. An application of Belzona® 1341 Supermetalgilde to all the transfer rolls (21) ensured that the planed lumber remained clean and unmarked while it was been processed. This saved the mill many hours in re-sanding time
