BELZONA® REBUILDS BAND SAW SLIDE

LUMBER PRODUCER
Vancouver Island, BC.

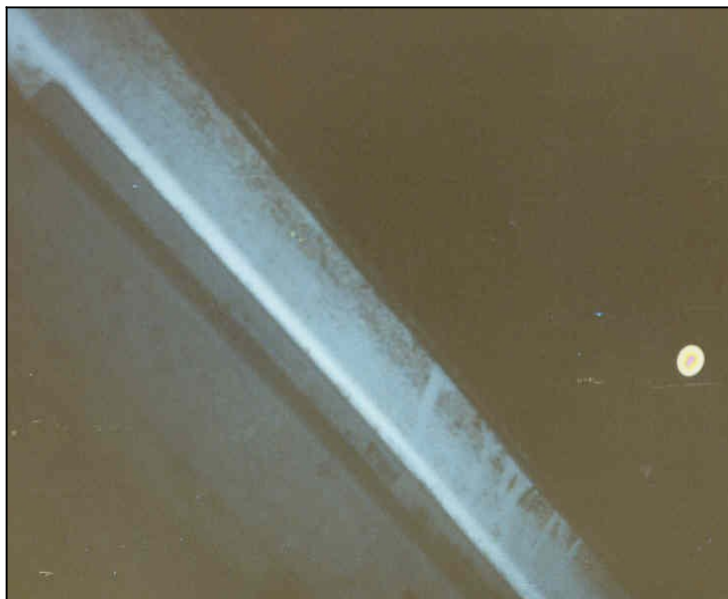
The constant attack from saw dust had worn away about 12 inches of the bandsaw slide causing it to jam.

1. View of worn band saw slide area.
2. Completed repair.

Belzona® 1311 Ceramic R Metal

Application carried out in accordance with a modified version of Belzona® Know-How Leaflets GSS-5
