BELZONA® REBUILDS KEY WAY AND SAVES DOWNTIME

LUMBER MANUFACTURER
British Columbia, Canada

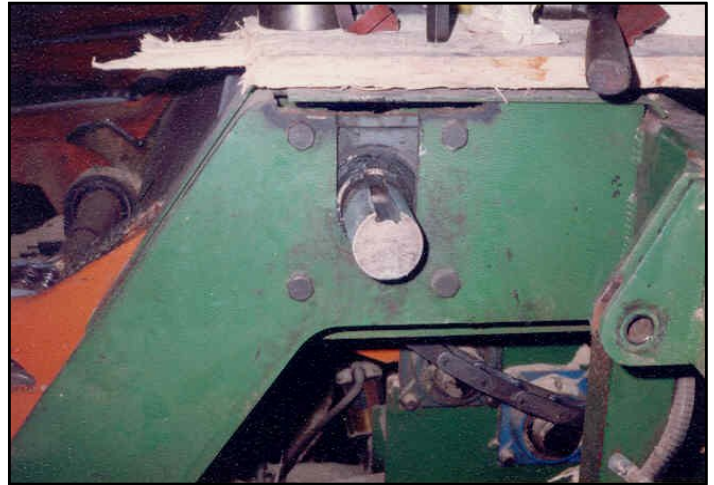
Keyway had become badly worn and sloppy.

1. View of damaged keyway
2. Keyway reset in Belzona 1111 Super Metal.
3. Drive flange use to locate and position keyway correctly.
