## BELZONA® REPAIRS DAMAGED SHAFT SAVING DOWNTIME

Lumber Mill  
Penticton, BC

Seized bearing had worn shaft

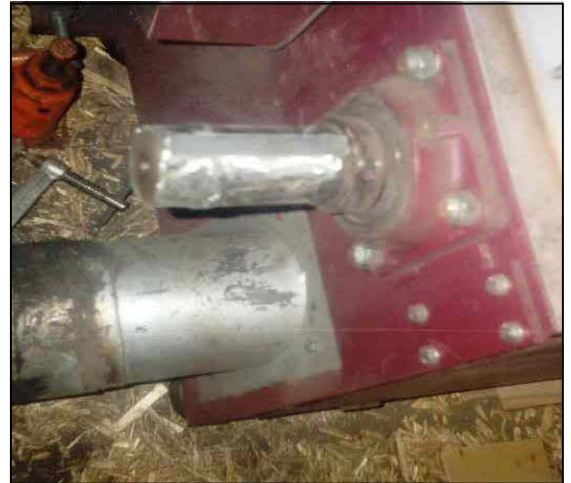
1. View of damage shaft
2. Repair in progress with mold in place
3. Mold removed and ready for reassembly.

Belzona® 1111 Super Metal is dimensionally stable enabling the shaft to be reformed and repaired using a simple mold. This eliminated the need for dismantling saving many hours of downtime.
