## BELZONA® REBUILDS WORN CHIPPER DISC POCKETS

Lumber Producer  
Port Alberni, BC.

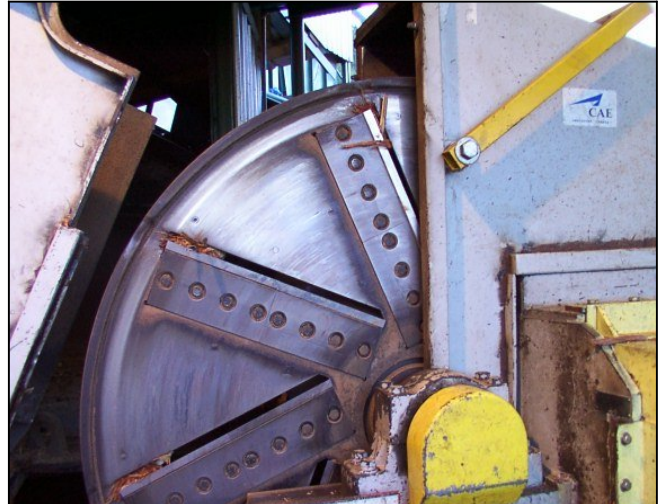
1. View of chipper disc.
2. View of worn chipper disc pocket prior to grit blasting.
3. Profile of pocket rebuilt with Belzona® 1812 Ceramic Carbide FP

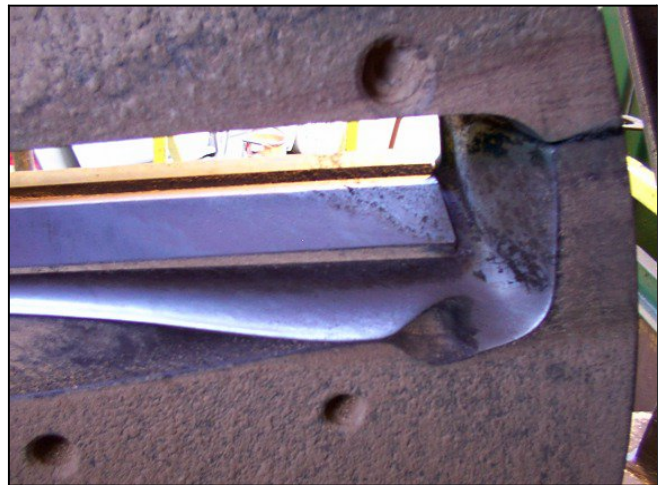
Worn chipper disc pockets will tend to produce degraded quality chips as well as increase the possibility of clogging at the corners.

This type of repair is often completed with low heat brass welding. This has to be very carefully executed to ensure that the chipper disc does not develop stress cracks from the heat. The Belzona solution requires no heat, thus eliminating this potential problem. The complete application can also be completed within a single shift without having to dismount the disc saving further downtime.
