BELZONA® REBUILDS WORN CHIPPER DISC POCKETS

Lumber Mill
Vancouver, BC.

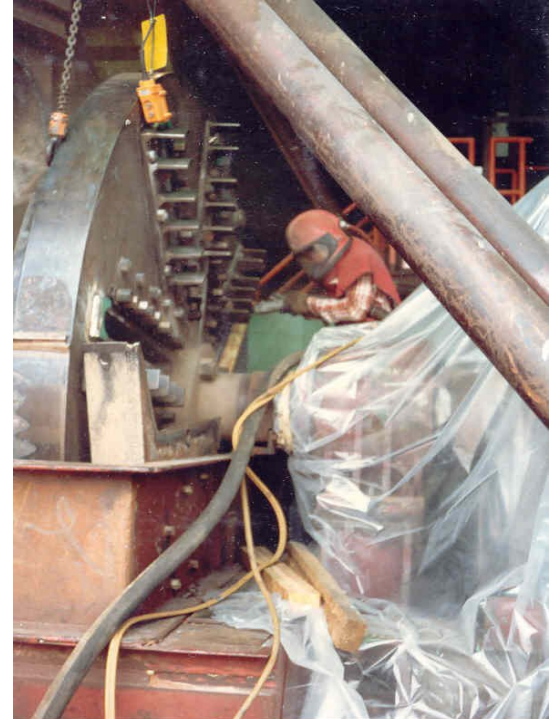
1. Grit blasting chipper disc pocket in progress.
2. View of worn chipper disc pocket.
3. Rebuilt pocket.

Using the Belzona method of rebuilding allows the pockets to be rebuilt without dismantling the disc. This repair can also be completed in a single shift ensuring the chipper is ready for start up at the onset of production at the beginning of the week.

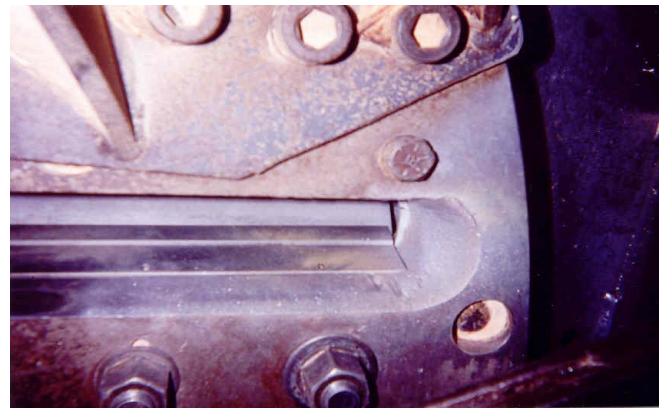
The chipper disc pockets had worn to a point where the wear was causing a concern.
