BELZONA® REBUILDS PLANER HEAD THROAT

Saw Mill
Nanaimo, BC.

May 2005

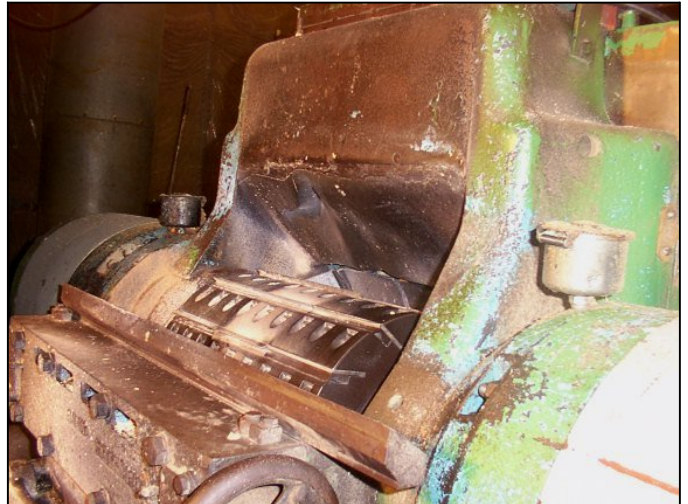
1. General view of planer head.
2. View of hole.
3. Not the prettiest application but nevertheless rebuilt and already in service..

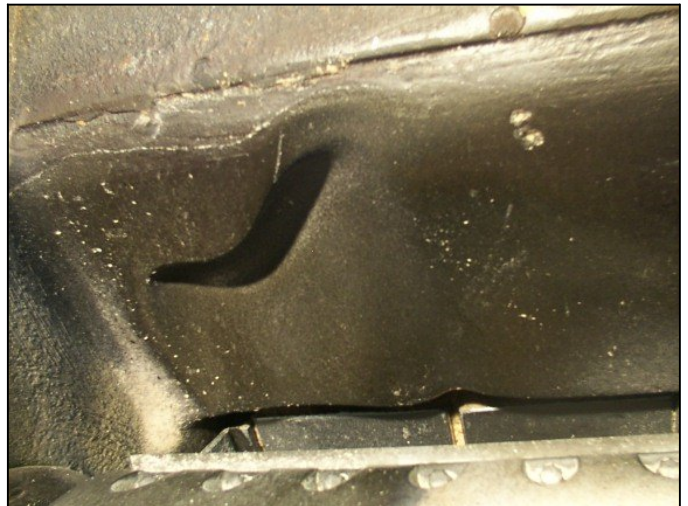
A hole had worn through the cast iron of this planer allowing wood shavings to be blown around and causing a breathing hazard
