BELZONA® RE-BUILDS AND PROTECTS ERODED TUG BOAT KORT NOZZLES

Vancouver, British Columbia, Canada
Tug boat operator.

August 1996

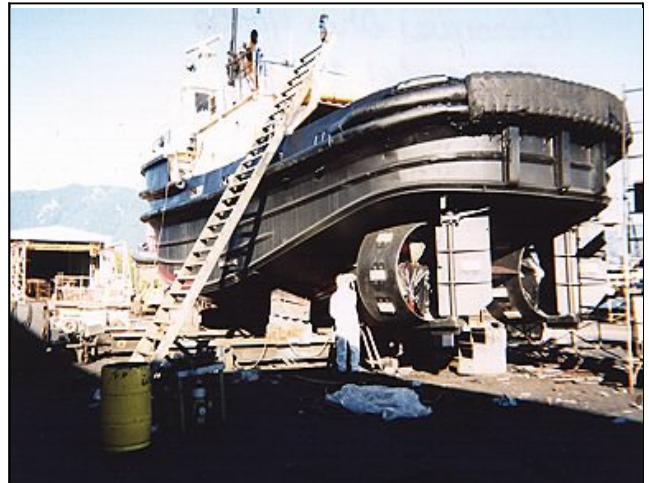
1. View of vessel in dry dock
2. Repairs to eroded and damaged areas in progress.
3. Completed application

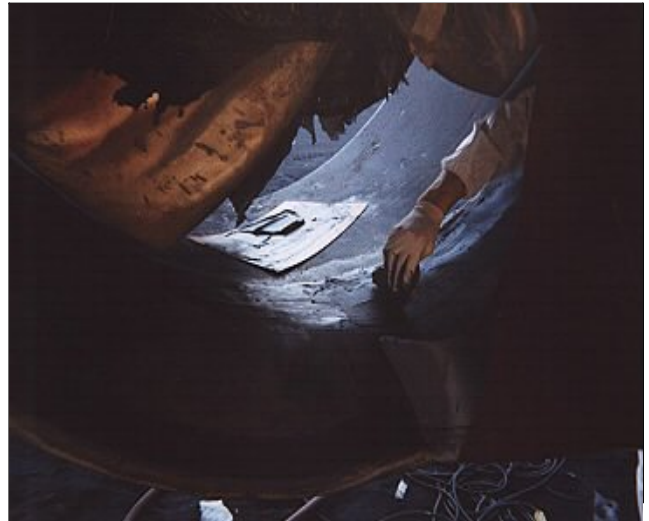
Tugs used for hauling log booms up and down the coastline. Extensive loss of metal around welds and stainless steel insert from bi-metallic corrosion.

Using Belzona® eliminated the need to do extensive welding to restore the lost metal. This was limited to repairing holes in the kort nozzle which is also used as a radiator to cool the engine. Excessive welding also causes stress cracking which can create a major problem during the dry docking as the vessel cannot be put to sea if it is not able to pass a pressure test. Re-building with Belzona® 1311 eliminates all these problems. Coating the repaired area with Belzona® 1321 improves the abrasion resistance of the surfaces and eliminates any bi-metallic corrosion.
