BELZONA® RE-BUILDS AND PROTECTS ERODED TUG BOAT KORT NOZZLES

Tug boat operator. Tugs used for hauling log booms up and down the coastline. Kort nozzle was dismantled and placed on the quay side for the main part of the application

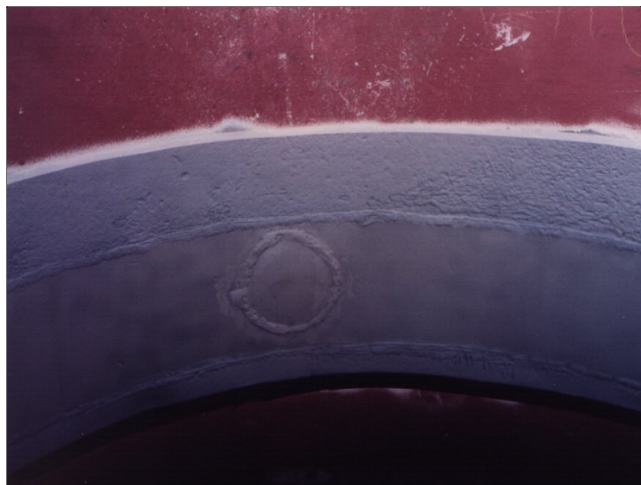
Bi-metallic corrosion had eroded much of the metal and welds adjoining the steel insert.

1. View of blasted kort nozzle showing erosion pattern
2. Application of Belzona® 1314 in progress
3. Coated kort nozzle remounted on vessel. Mounting cover caps sealed with Belzona® 1311 before being over coated with 1341
