## BELZONA® REBUILDS AND PROTECTS KORT NOZZLES

LOG TRANSPORTER  
Vancouver, BC

August 1996

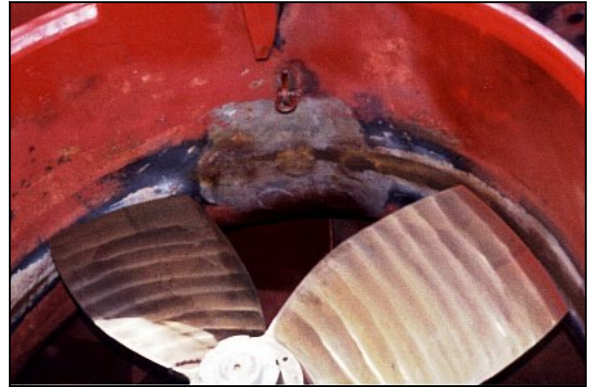
The kort nozzles on this and 2 sister vessels have been protected from erosion corrosion problems by Belzona since 1987. This vessel had been in service for 3 years at the time of it's dry docking. The nozzles had developed a number of leaks from inside and required extensive welding. Despite the good condition of the original coating in areas unaffected by the welding, customer decided to re-last the entire nozzle and re-coat with Belzona®.

1. View of areas requiring welding
2. View of nozzle showing extent of erosion after 3 years in service.
3. Nozzles re-coated with Belzona® 1341 Supermetalglide

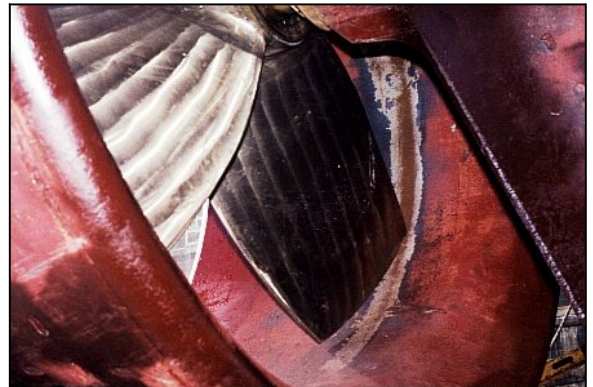
Vessels mild steel kort nozzels subject to continuous bi-metallic erosion as well as abrasion attack.
