BELZONA® REBUILDS ERODED RUDDER PINTLE HOUSING

DRY DOCKING COMPANY
Vancouver, BC.

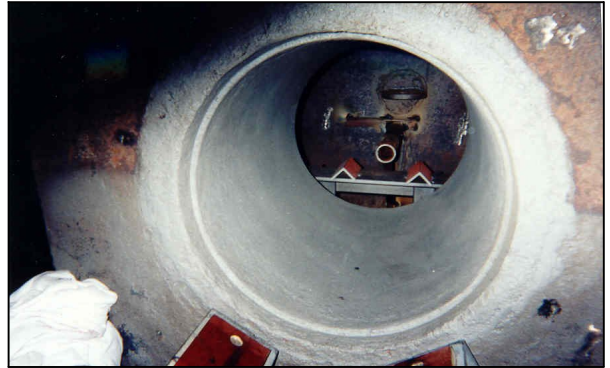
Bi-metallic corrosion had eroded much of the metal – about ¼ inch – from the rudder pintle housing
