BELZONA® PROTECTS MARINE PROPULSION JETS

CUSTOMER
FIRE DEPARTMENT
Vancouver, BC.

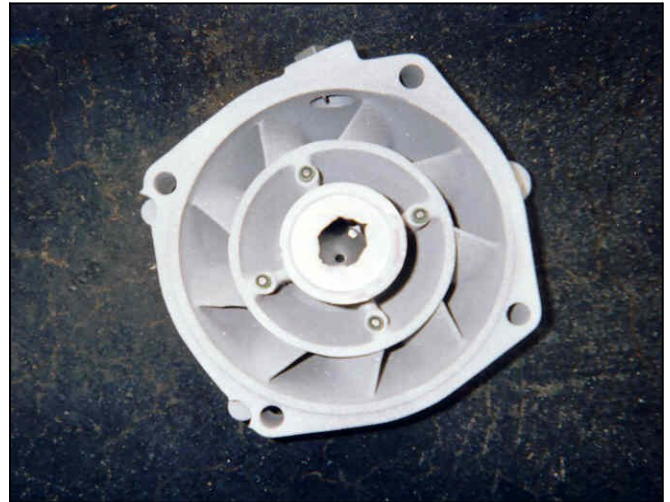
1. New units blasted and ready for application of 1st coat
2. Application of 1st coat Belzona® 1341 Supermetalglide.
3. Application of 2nd coat Belzona® 1341 Supermetalglide.
