BELZONA® REBUILDS MARINE JET DRIVE PROPULSION UNITS

FIRE DEPARTMENT
Vancouver, BC.

August 2001

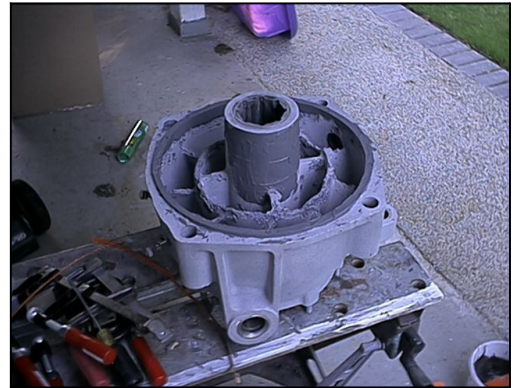
Bi-metallic corrosion had eroded much of the metal despite the placement of sacrificial zinc anodes on side of units.

1. Units after blasting showing extent of erosion with center and outer locating ring rebuilt.
2. Rebuild of other areas in progress using flexible plastic forms and G-clamps.
3. All rebuilding completed with filing and sanding in progress to ensure smoothness.
4. Application completed with units protected with 2 coats of Belzona® 1341
