## BELZONA® REBUILDS AND PROTECTS SEAWATER STRAINERS

DRY DOCK COMPANY  
Vancouver, BC

March 2000

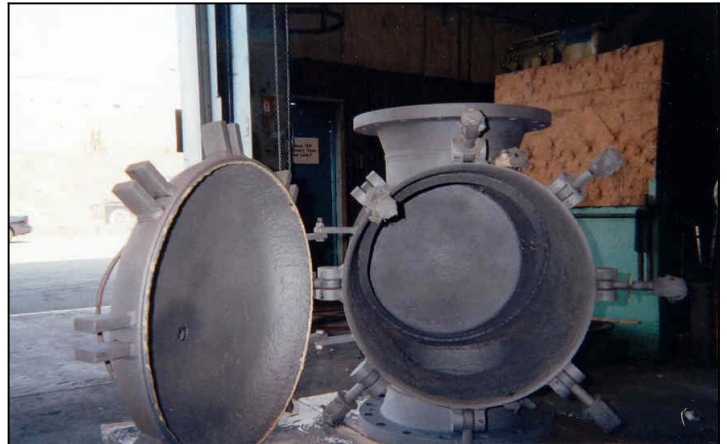
1. View of vessel after grit blasting
2. Application in progress with eroded areas rebuilt with Belzona® 1311 and over coated with 2 coats of Belzona® 1321.
3. Completed application with outside of vessel protected with Belzona® 5111
