BELZONA® REBUILDS AND PROTECTS ONBOARD SEAWATER STRAINER

INTERNATIONAL SHIPPING COMPANY
Vancouver, BC

August 2000

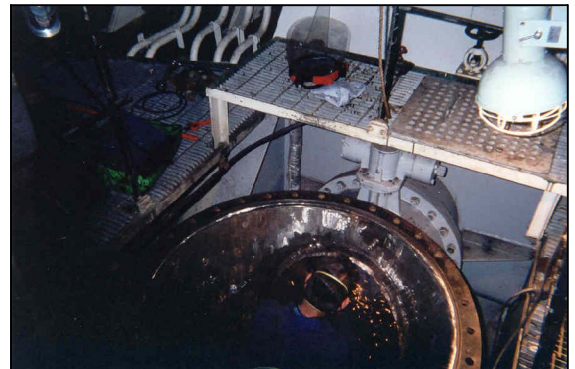
1. View of vessel preparation in progress.
2. Application of 1st coat of Belzona®1321 to wet out the metal surface.
3. Repairs to eroded and damaged areas in progress.
4. Application complete.

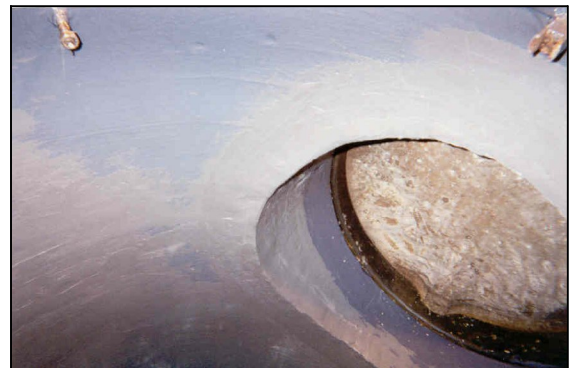
Bi-metallic corrosion had eroded much of the metal adjoining the welds. The vessel was also constructed of a very poor grade mild steel which resulted in massive losses of metal
