BELZONA® REBUILDS ERODED CORRODED TAILSHAFT

TUG BOAT OPERATOR
Vancouver, BC

August 1996

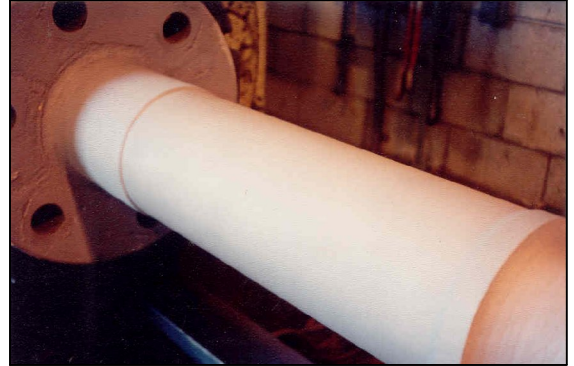
Sever corrosion had eroded the seal area of the tail shaft.

1. Shaft set up in lathe after under cutting and grit blasting
2. Application of Belzona® 1111 in progress.
3. 1st cut in progress.
4. Completed shaft repair

Application carried out in accordance with Belzona® Know-How Leaflets
MPT-1
