BELZONA® REBUILDS WATER JET PROPULSION UNIT FLANGE SEAL AREA

FIRE DEPARTMENT – FIRE BOATS
North Vancouver, BC

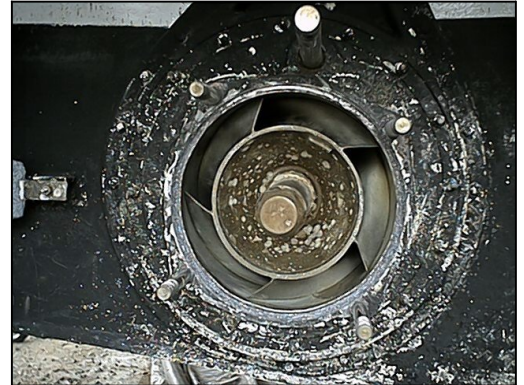
1. The eroded area was ground clean to remove all oxidized metal.
2. Belzona® 1111 was applied to eroded area and Belzona® 9411 Release Agent was applied to the male portion of the water jet propulsion unit before a light coat of Belzona 1111® was applied to it. The units were then bolted together squeezing the excess material out the sides of the unit.
3. After curing propulsion unit removed showing newly formed flange recess.
4. Close up of reformed flange after excess material had been ground away.
