BELZONA® REBUILDS RUDDER PINTLE HOUSING

DRY DOCKING COMPANY
Vancouver, BC.

September 1999

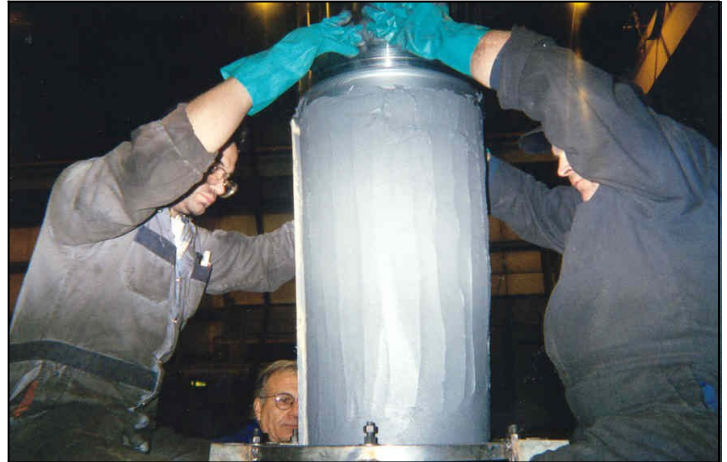
1. View of rudder pintle liberally coated with Belzona® 1111.
2. Pintle fully inserted and centered using a jig tack welded to the top of the rudder.
3. Completed application. Note finish of newly formed bore.

Rudder pintle housing was badly eroded / corroded and required rebuilding.

Repairing pintle housing this way eliminates the probability of developing stress cracks and can be completed in a lot less time. The repair also eliminates the possibility of bimetallic corrosion taking hold again as it isolates the two metals present in the housing assembly.
