BELZONA® REBUILDS AND PROTECTS KORT NOZZLE

TUG BOAT OPERATOR
Vancouver, BC

August 1995

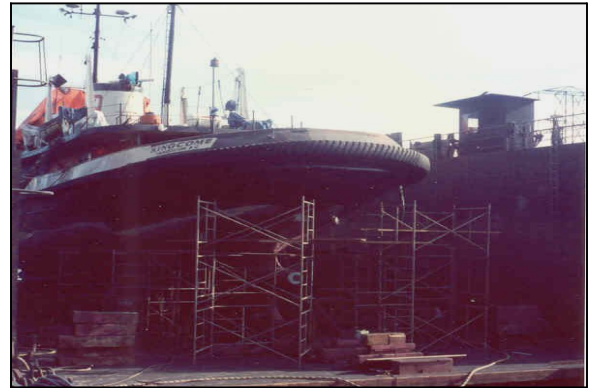
1. View of tug boat and kort nozzle removed
2. Application of 1st Coat of 1341 completed with application of 2nd coat in progress.
3. Application of 2nd coat completed.
4. Nozzle reinstalled. Plug areas rebuilt with Belzona®1311 prior to application of Belzona®1341.

Bi-Metallic erosion
