BELZONA® REBUILDS ERODED FLANGE FACE

DND
Esquimalt, BC

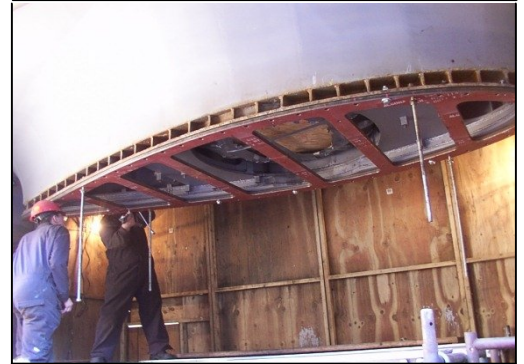
1. Flange former positioned for "dry run" to ensure that everything lines up correctly.
2. Close up of flange showing spacers.
3. Application of Belzona® 1121 Super XL Metal in progress.
4. The flange former was systematically tightened up squeezing out the excess material which was wiped away before it set hard. Application completed
