## BELZONA® PROTECTS RUDDERS FROM CORROSION & CAVITATION

Ferry Operator  
Victoria, BC

May 2003

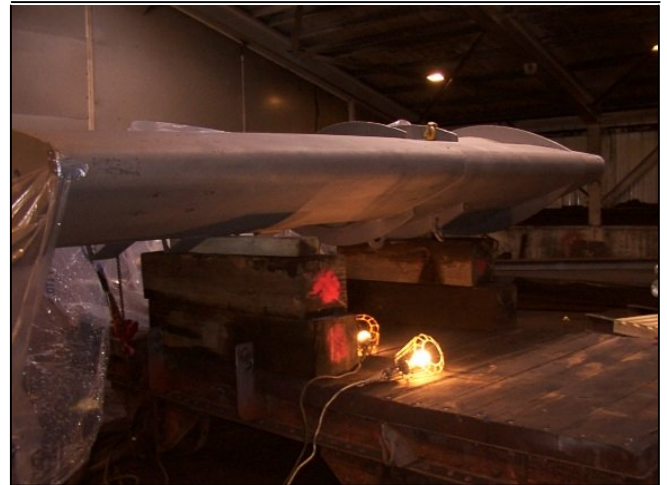
1. Rudder after grit blasting
2. Excessively cavitated areas are rebuilt with Belzona® 1311 before being over coated with Belzona® 1341 Supermetalglide.
3. Final coat of Belzona® 1341 Supermetalglide (Grey) applied and force cured with heat lamps to meet deadline.
