BELZONA® ELASTOMERS PROVIDE A PERFECT SEAL

Cruise ship

May 1995

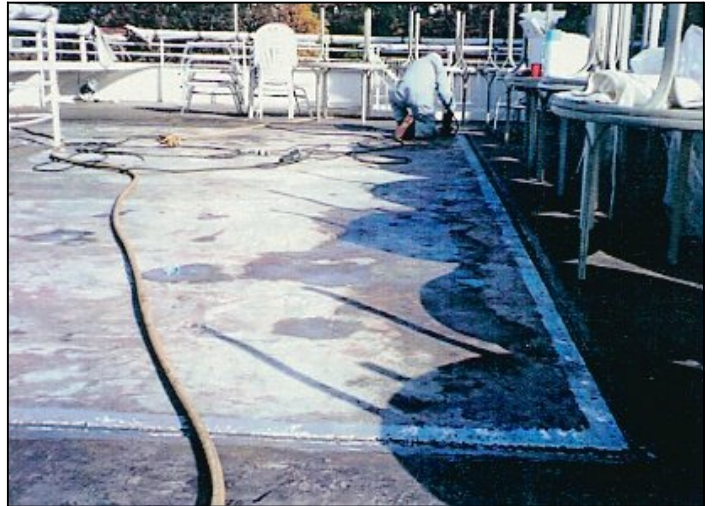
1. Preparation of the areas to be sealed in progress.
2. Close up of prepared area and extent of bimetallic corrosion.
3. Completed seams

The ships engineer had insisted that the seams be sealed with Belzona based on previous experiences with the products. After the sealing of the area had been completed, the entire area was flooded with more than 6 inches of water for 24 hours as a test. No leaks were found. As a result of this 2 further deck areas were also sealed.

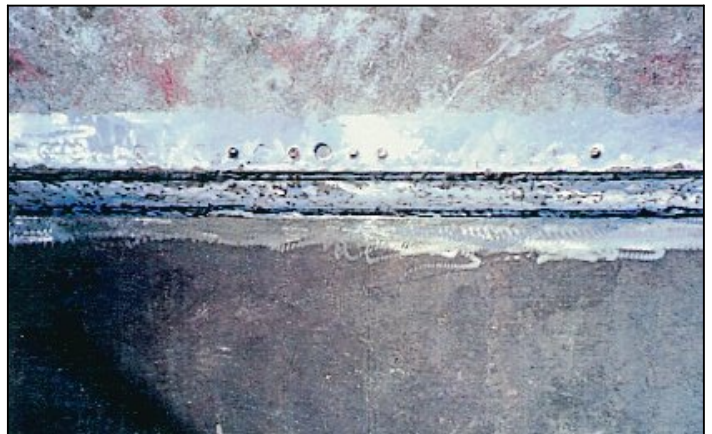
Water was continually leaking into area where most of the vessels sensitive electrical equipment was housed. To complicate the problem the deck over this section was aluminum and thus posed a major bimetallic corrosion problem.
