## BELZONA® REBUILDS RUDDER PINTLE

Dry Docking Facility  
Victoria, BC

Rudder pintle corroded

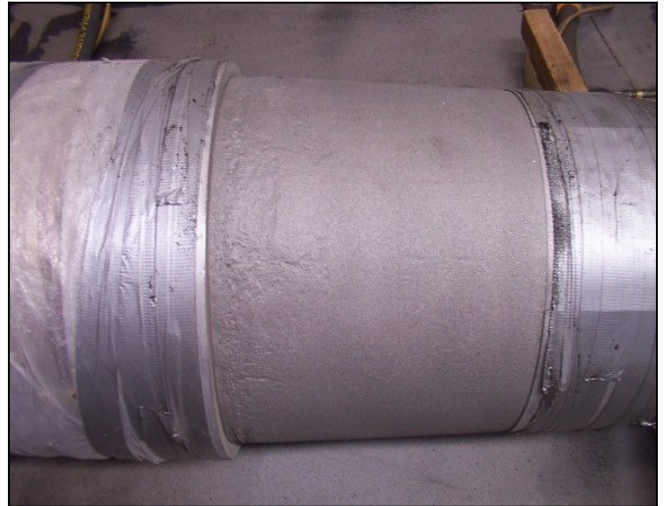
1. Damaged portion of pintle rebuilt with Belzona® 1111 Super Metal.
2. Pintle in the lathe and machining in progress.
3. Repaired pintle.

Vessel was due to have pintle housing rebuilt with Belzona when it was found that the pintle mating surfaces were also badly corroded. Approval allowed the shipyard to rebuild the problem pintle with Belzona saving many hours of machining time ensuring that the dry docking repairs remained on schedule. A number successful and major rudder housing rebuilds over the past few years for this Company have reinforced their confidence in Belzona.
