BELZONA® RESEATS SPLIT COOPER BEARING ON PROPELLER SHAFT

Passenger Ferry Operator
Vancouver, BC.

April 2004

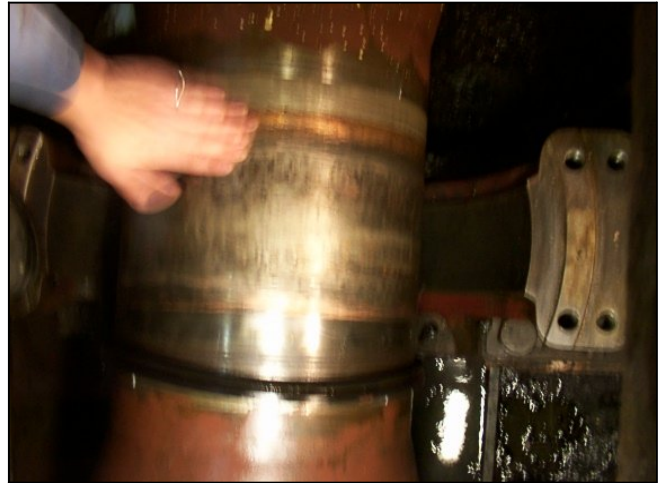
A problematic bearing had badly scored the propeller shaft making it difficult to obtain an 85% surface contact as required by the marine insurers. The fit was actually showing less than 50%

1. View of damaged portion of the propeller shaft.
2. The propeller shaft was thoroughly degreased.
3. Belzona® 1321 Ceramic S Metal was brushed onto the damaged portion of the shaft. The cooper bearing which had been previously coated with Belzona 9411 Release Agent, was then placed in position before being tightened squeezing out any excess Belzona product.
