## BELZONA® REBUILDS AND PROTECTS FERRY RUDDER HORNS

Passenger Ferry Operator  
Vancouver, BC

December 2004

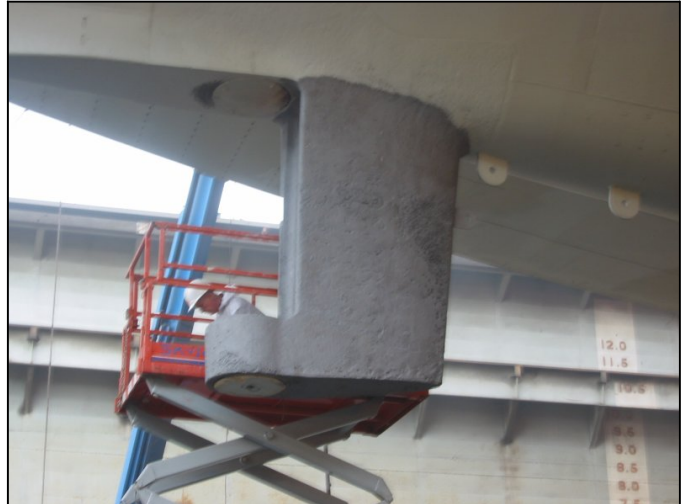
1. Rudder horn after grit blasting to a near white metal finish
2. Application of 1<sup>st</sup> coat in progress
3. Completed application
