BELZONA® REBUILDS AND TUG BOAT PROTECTS KORT NOZZLES

TUG BOAT OPERATOR
Richmond, BC.

June 2005

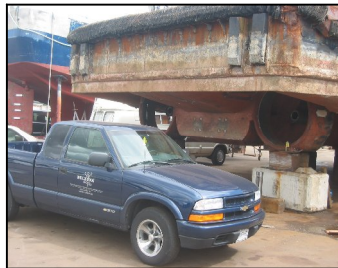
Both kort nozzles had become badly eroded. Consideration was given to relining nozzle with stainless steel. However, this created clearance problem which would have necessitated trimming the props. The Belzona option was quickest, easiest and most economical of the two and there was now danger of inducing stress cracks, a problem associated with welding.

1. Blasting of the two nozzles completed (Inset: View of Tug boat)
2. Application of the 1st coat in progress. After this had set up for approximately 1 hour eroded areas were rebuilt.
3. Completed application
