## BELZONA® RESEATS MARINE VESSEL CUTLASS BEARING

Ferry Operator  
Victoria, BC

February 1998

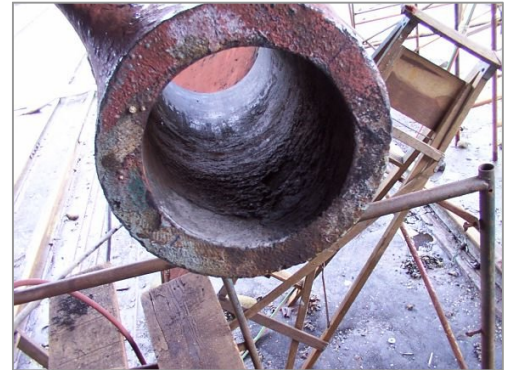
The stern tubes of the vessel had become badly eroded making it impossible to insert and reposition a new cutlass bearing effectively

1. View of corroded shaft housing
2. Injection holes drilled at both 12.00 O'clock and 6.00 O'clock of the housing.
3. After grit blasting to remove all signs of corrosion.
4. Completed application.
