## BELZONA® 1341 SUPERMETALGLIDE PROTECTS RUDDERS

Dry Dock  
Vancouver, BC

February 2006

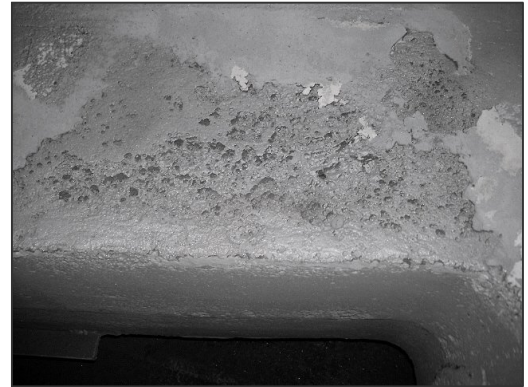
Rudders were showing sever metal loss in areas where cavitation attack prevalent .

1. View of one of the many badly cavitated areas on the two rudders
2. Rebuilding of eroded areas in progress
3. Application of 1<sup>st</sup> coat of Belzona 1341 Supermetalgilde in progress
4. Application of 2<sup>nd</sup> coat of Belzona 1341 Supermetalgilde completed
