BELZONA® 1000 SERIES PRODUCTS USED TO RESEAT TAIL SHAFT BUSHING

Drydock Company
Port Alaberni, BC

February 2005

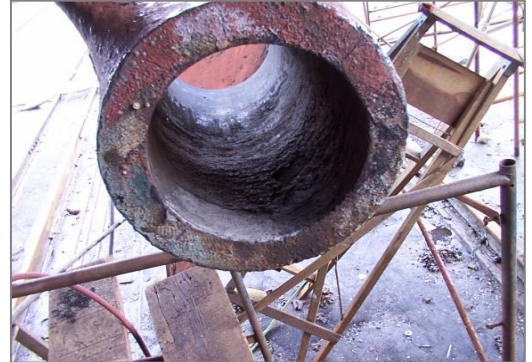
The pintle housing was badly corroded.

1. View of corroded eroded tail shaft housing
2. After grit blasting to a near white metal finish – SSPC SP 10
3. New bushing coated with Belzona 9411 Release Agent
4. Completed application – After centralizing and setting bushing in position the cavity behind it is injected full of Belzona 1321 Ceramic S Metal. Note injection port on underside of housing
