BELZONA® REPAIRS CABLE REINFORCED CONVEYOR BELT

COAL MINE
British Columbia, Canada

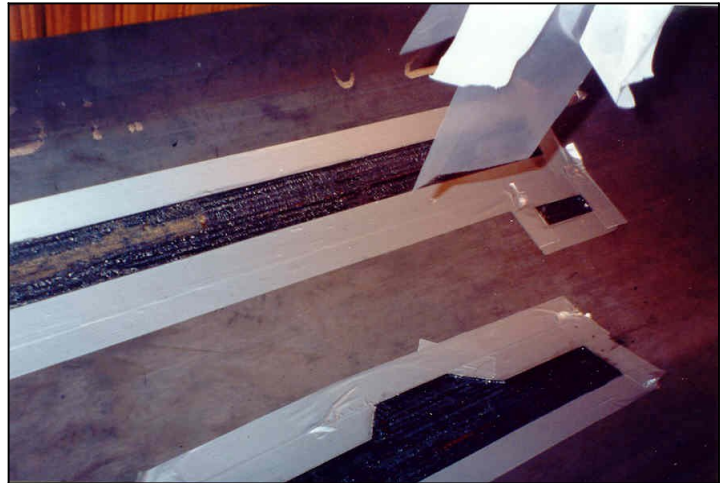
Cable stayed belt would develop cracks over a period of time.

1. View of preparation in progress
2. Close up of one of the repair areas.
3. Completed application

Because of its rapid set up time coupled with as quick development of mechanical strength, Belzona® 2311 SR Elastomer allowed repairs to be made to the belt during unscheduled or short shut downs
