BELZONA® REBUILDS MAIN PIVOT SHAFT ON SITE

COAL MINE
British Columbia, Canada

Original bearing had badly worn the main pivot shaft of this excavating crane

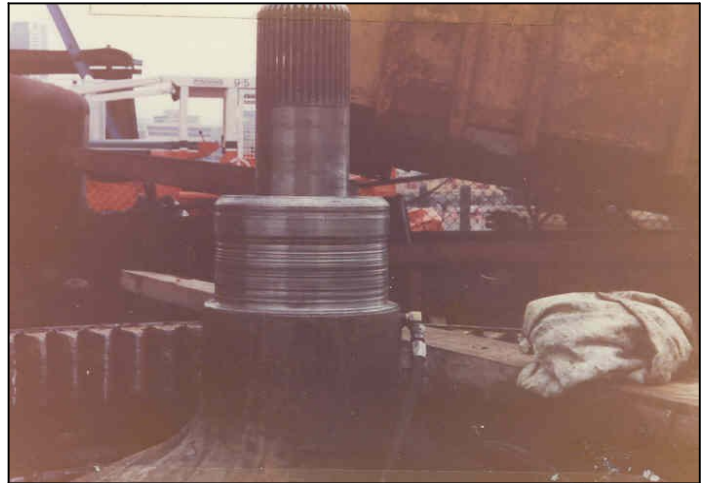
1. View of preparation in progress
2. Application in progress.
3. Completed application with mold still in place. Mold removed after material had set up leaving a remolded bearing area.

Application carried out in accordance with Belzona® Know-How Leaflet MPT-2
