## BELZONA® 2200 SERIES ELASTOMERS REPAIR CUT IN TIRE

Tire on earthmoving equipment had been badly damaged.

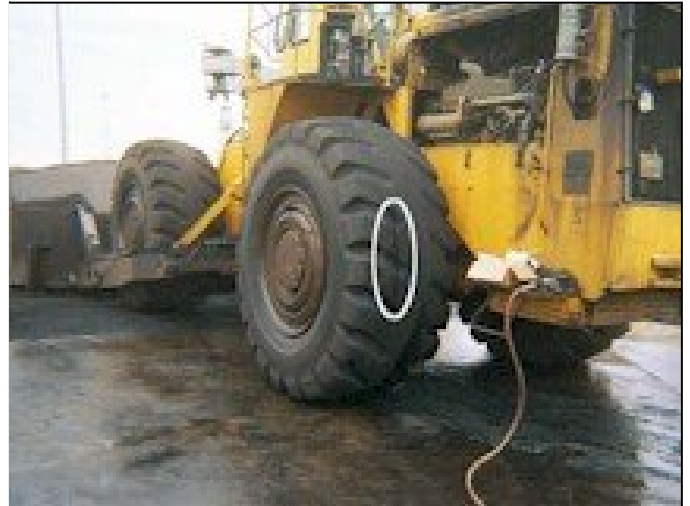
1. View of equipment and the extent of the damaged area
2. Surface around the damaged area prepared and coated with Belzona® 2911 QD Conditioner.
3. Damaged area sealed and rebuilt with Belzona® 2211 MP Hi-Build Elastomer.
