## BELZONA® REBUILDS WORN CAT D9 SPLINESHAFT ASSEMBLY

Mining operation  
Tumbler Ridge, BC.

The main drive spline on D-9 cat had worn loose over many years of service.

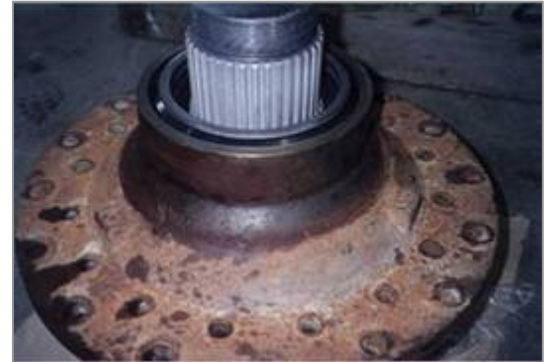
1. View of worn spline shaft assembly.
2. Belzona 1111 Super Metal applied to worn splines
3. Components reassembled.
4. The main framework that the Spline assembly will be bolted to.
