BELZONA® USED TO REPAIR AND SEAL CRACKED TRANSMISSION CASING

Repairing cracked and leaking transmission housing

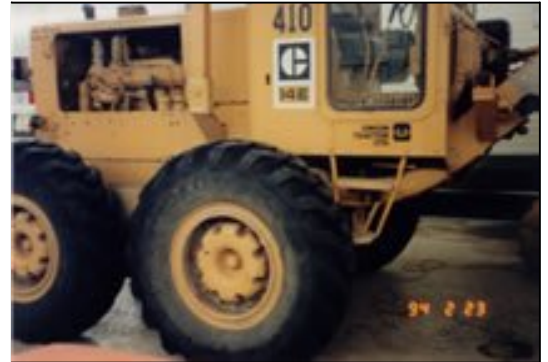
1. View of equipment.
2. Crack "v" out and the surface area around it roughened
3. Belzona 1111 Super metal applied to the area around the repair.
4. A reinforcement plate bolted over the uncured Belzona material to provide additional mechanical strength to the area.
